## ADDENDUM NO. 4

**SCC Mohr Hall Replacement**

**LRCCD BID NO. 18025**

**Section 00 31 26  
Hazardous Materials Work Plan  
For  
Sacramento City College Mohr Hall Demolition Project  
3835 Freeport Boulevard, Sacramento, CA 95822**

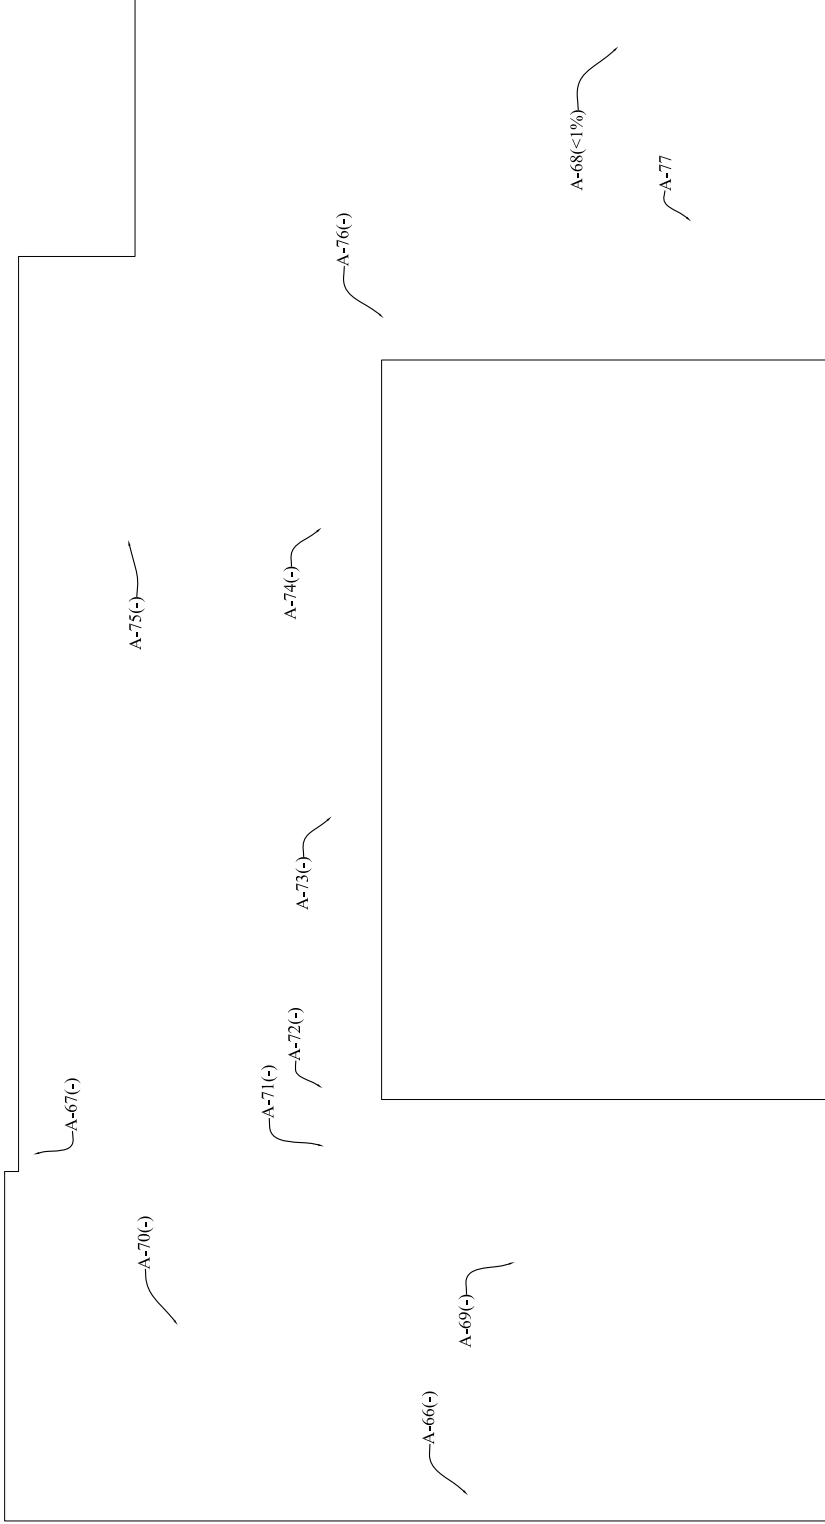
scale: 1/32"=1'-0" date: May 25, 208	drawing title: Asbestos Survey Roof Plan
	drawing no.: 2 drawing 2 of 4

- Asbestos <1% in silver paint on built up roofing under foam roof.

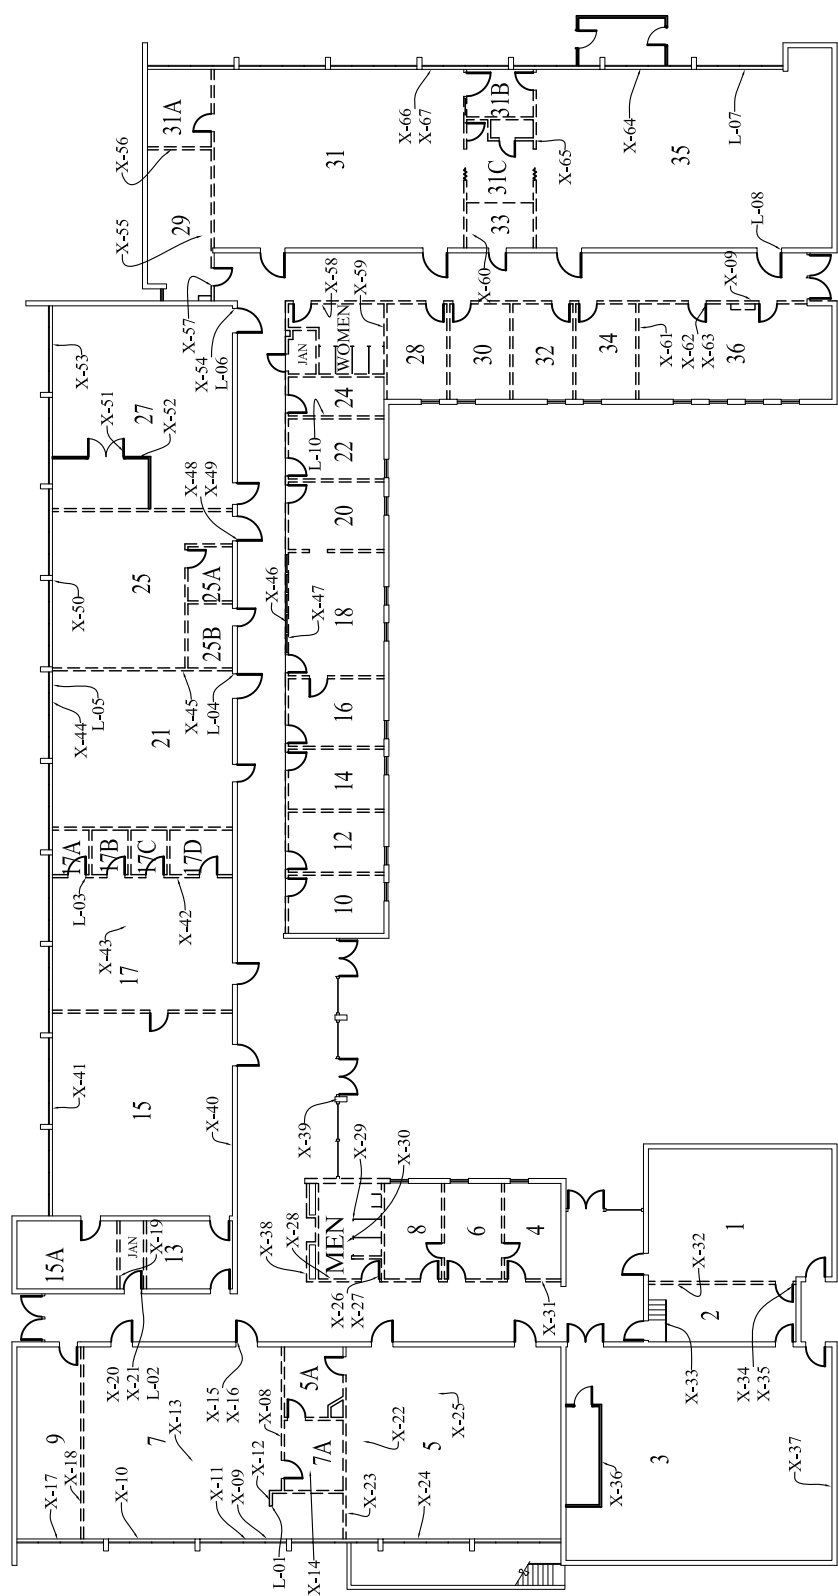
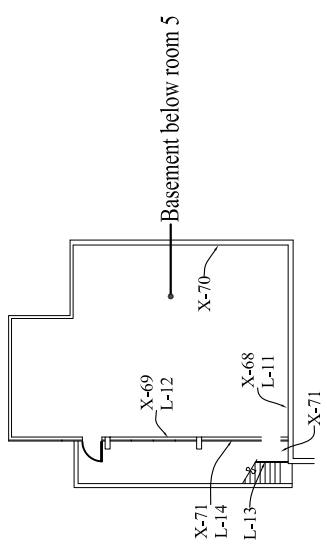
- Lead Based Paint >5000 mg/kg**
- Beige paint on metal hand rails in room 2, and at exterior stairs to basement.
  - Red, green, and orange paint on interior metal door frames.
  - Beige paint metal louvers at basement mechanical room.
- Lead Containing Paint >600 mg/kg**
- Beige paint on concrete walls.
  - Green and beige paint on interior plaster walls and ceilings.
  - White paint over red on roof air handlers and ducts.

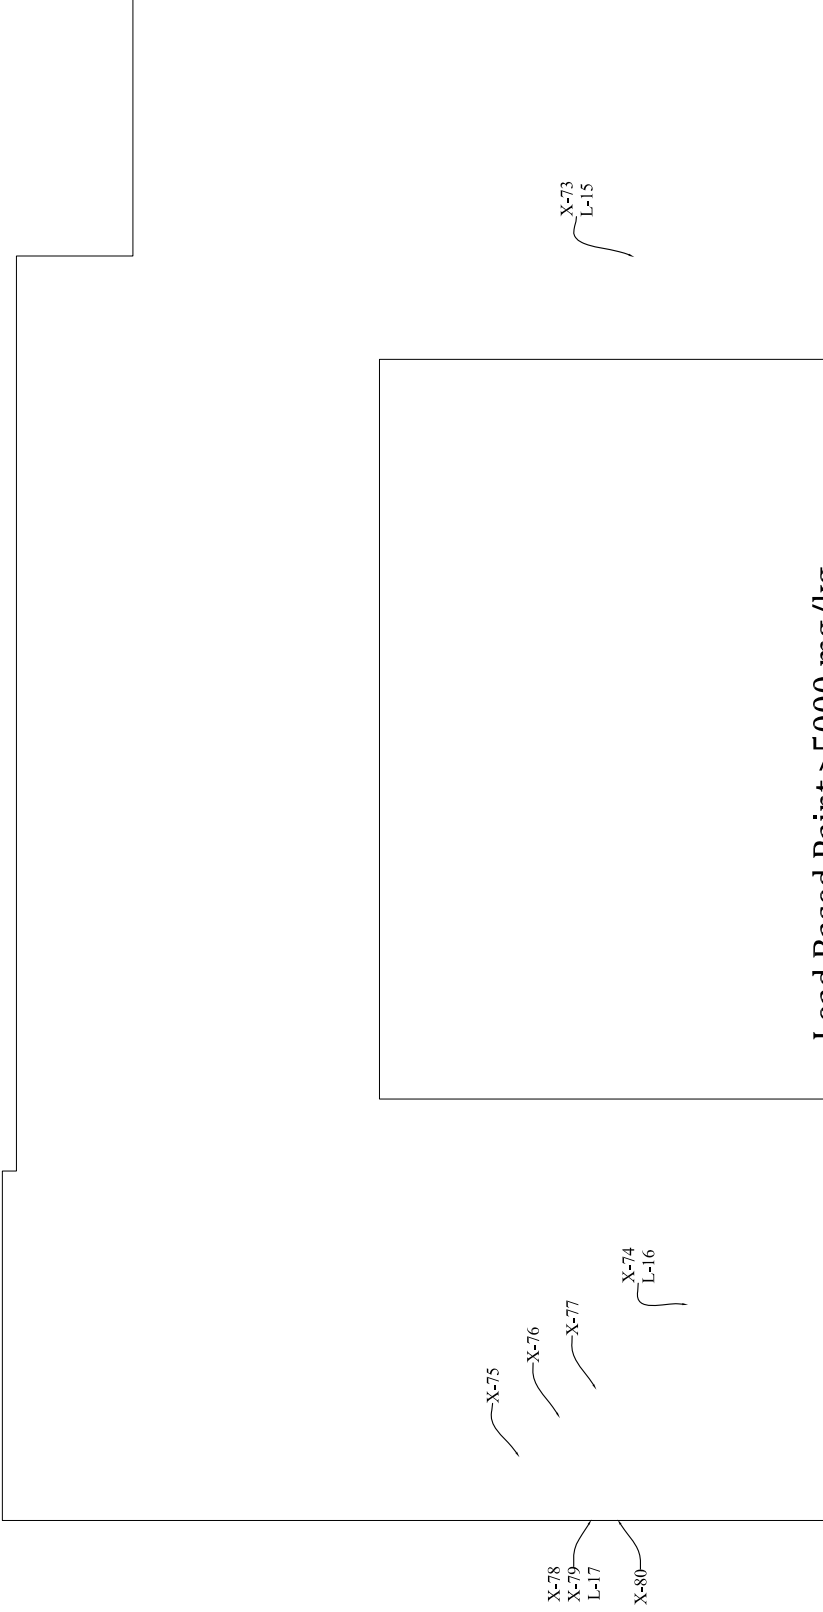
**Lead Based Paint >5000 mg/kg**

- Beige paint on metal hand rails in room 2, and at exterior stairs to basement.
- Red, green, and orange paint on interior metal door frames.
- Beige paint metal louvers at basement mechanical room.
